序号	报告编号	发布时间	结论	影像资料
1	GX-B1547/20-2-24023~24026	2024/11/1	所检项目合格	 
2	GX-B1547/20-2-24027~24029	2024/11/1	所检项目合格

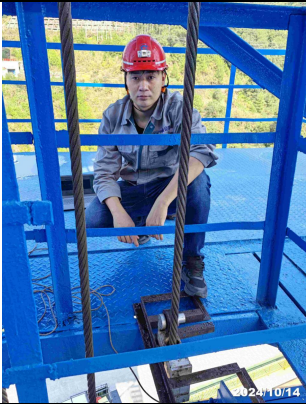
3	GX-B1598/24-2-24249	2024/11/6	实测钢丝绳有效截面积损失百分比最大为1.85%，小于5%为正常。

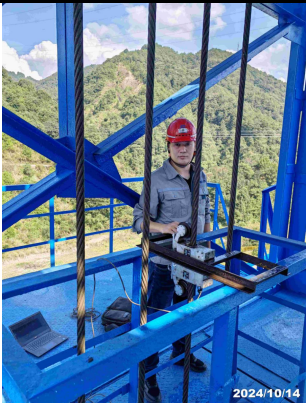
4	GX-B1598/24-2-24250	2024/11/6	实测钢丝绳有效截面积损失百分比最大为2.04%，小于5%为正常。

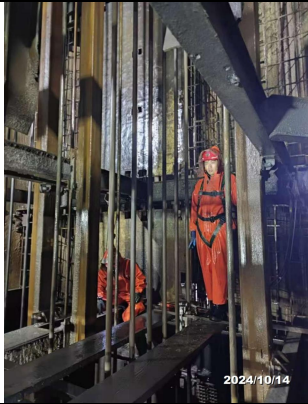
7	GX-B1598/24-2-24253	2024/11/6	实测钢丝绳有效截面积损失百分比最大为0.98%，小于5%为正常。
